# Damage Assessment of Urban Interface Masonry Buildings after a Severe Wildfire along with a Comparison of NRC-2018

Soyer, A. and Ghatte, H.F. (2025). *Damage Assessment of Urban Interface Masonry Buildings after a Severe Wildfire along with a Comparison of NRC-2018*. Journal of Innovative Science and Engineering. 9(1): 118-133

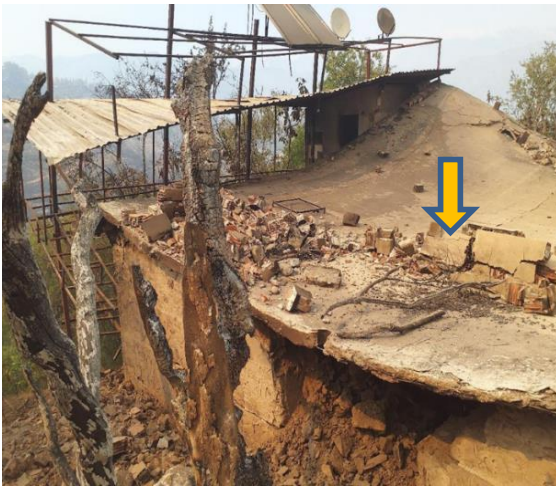
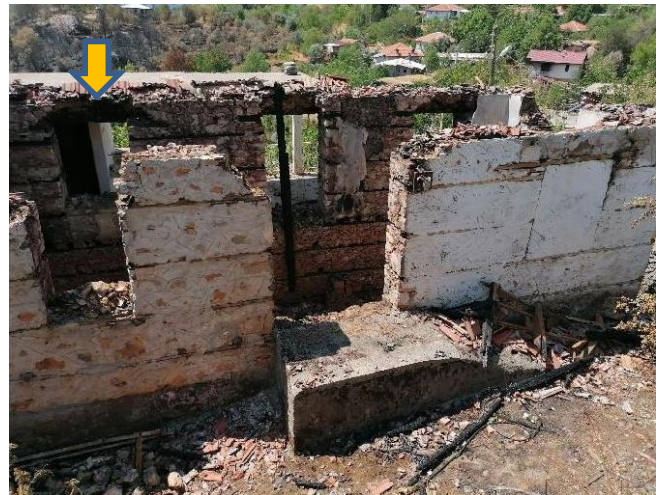
In masonry buildings, fire primarily destroyed roofs, wooden beams, and floors. The burning of the timber structural elements that used to have a balanced condition of the walls mainly caused deformation and several kinds of cracks (see Figure 6). Furthermore, the unbalanced situation causes the disconnection of the joints and local failures. In many cases, reinforced concrete floors lost their capacity and collapsed or had deformation based on the instability conditions of the masonry walls absence of any kind of connections was not considered. Due to the low heat resistance of reinforcing bars, it deforms in fires at high temperatures. Although it was protected because of the cover of concrete, its deformation becomes inevitable as the exposure time increases.

**Figure 6:** The collapse of the reinforced concrete slabs based on the failure in the walls (a and b).

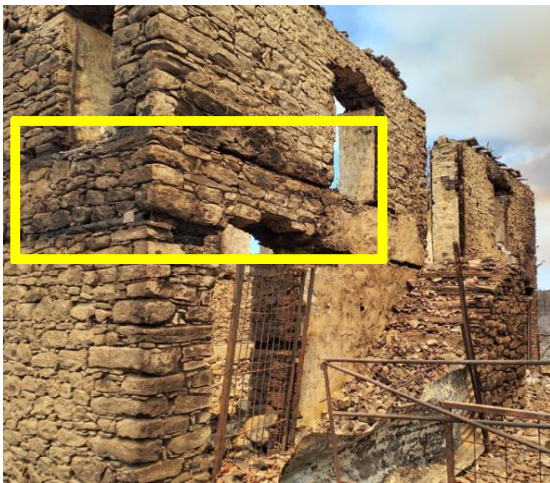
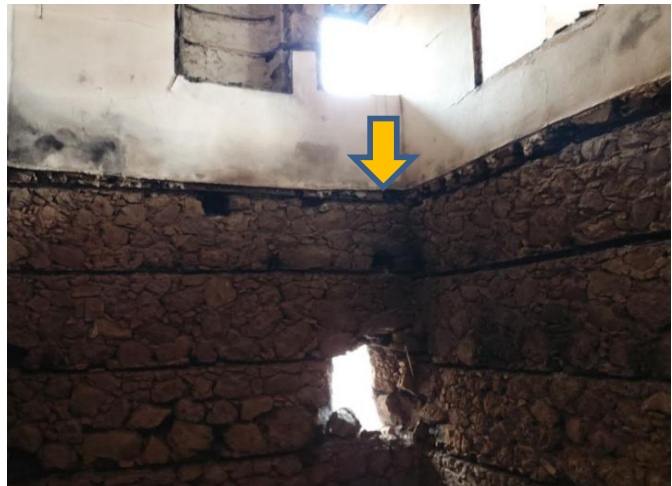
The local structural system of masonry buildings in Manavgat is mainly based on masonry stone walls with wooden beams located inside of the wall (see Figures 7-9). Unfortunately, when the beams were subjected to fire, the stability of the masonry walls dramatically led to different kinds of failures. In some cases, the slabs (reinforced concrete slabs) could control the rate of fire in a safe direction where the wooden roof and beams were quickly subjected to fire and failure.

**Figure 7:** Timber beams, slabs, and roofs have been destroyed by fire (a and b)

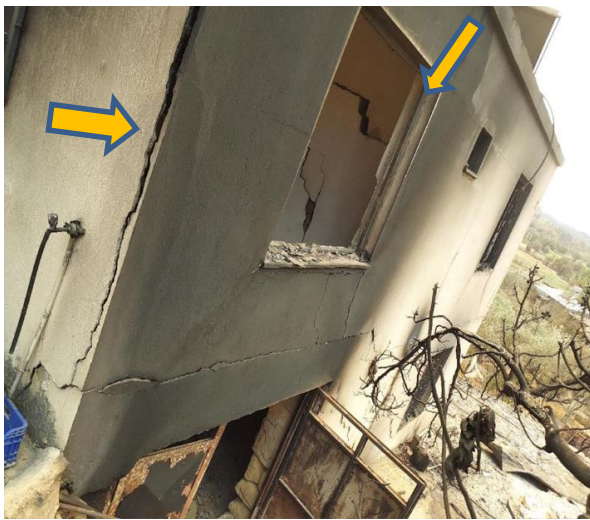
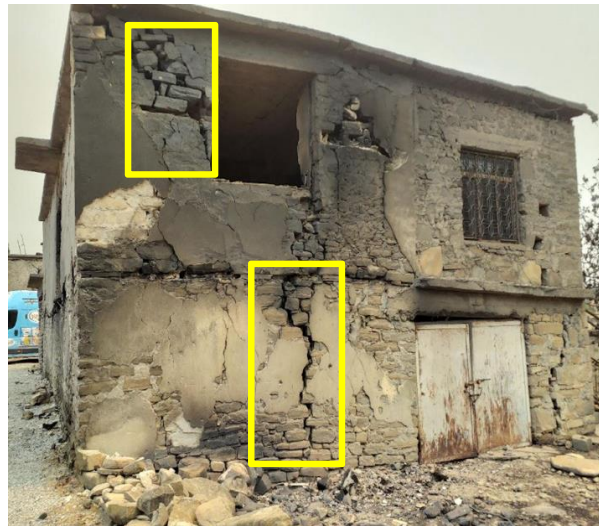
The observation of the cases showed that the separations and deep cracks in wall-to-wall connections, slab to slab-to-wall joints happened severally in masonry buildings. Furthermore, high temperatures destroy the properties of the mortar and bonding materials causing the separation of the walls, especially in terms of vertical and horizontal

separation in wall joints (see Figures 8 and 9). Another observation expressed that the plaster, which was made to obtain a flat surface on walls, was separated from the walls based on the effect of high temperature. It shows that in masonry buildings high temperatures destroyed the cohesion between the wall and plaster not only on the inside of the building but also on the facades. Generally, all of the buildings with different kinds of structural systems are subjected to spalling of plasters in the facade as well as inside of the buildings based on the different temperatures and materials (see Figures 10).

**Figure 8:** The materials lost their qualities (a and b- deep cracks and separations)

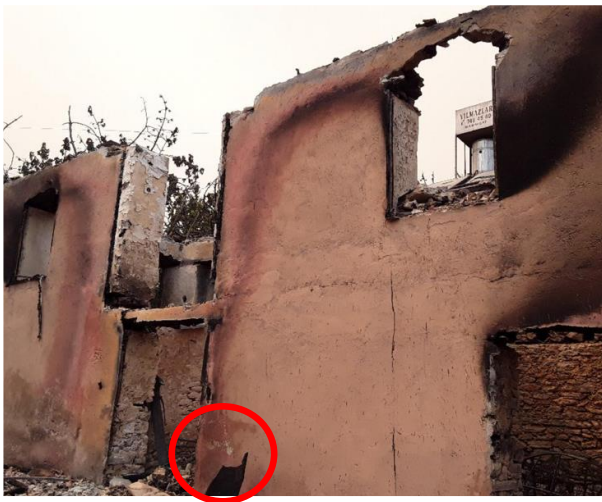
**Figure 9:** Spalling of plasters in the facade

4. Spalling of plasters in the facade as well as inside of the buildings is observed based on the different temperatures and materials.

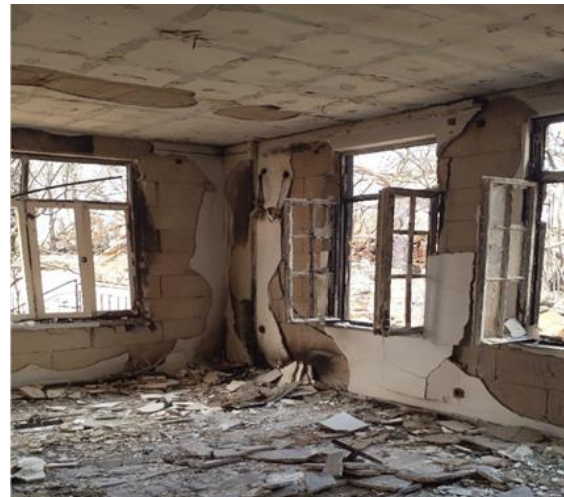
**Figure 10:** Inside spalling of plaster

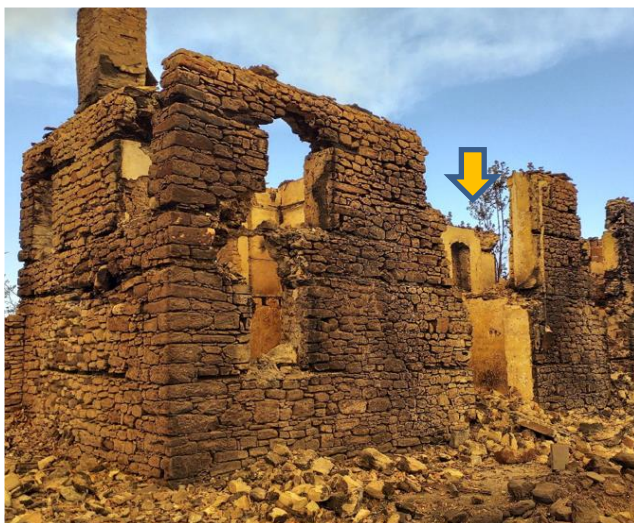
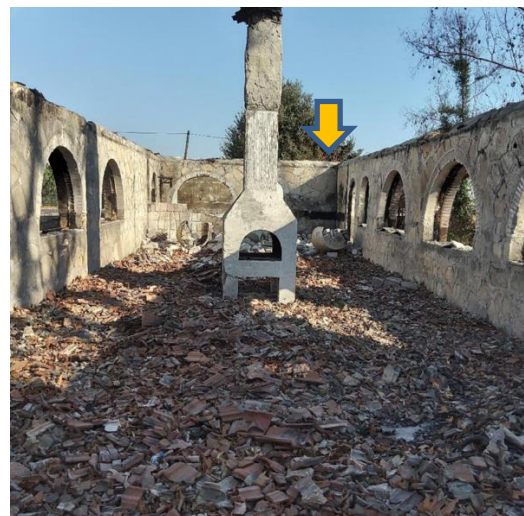
**Figure 11:** Timber roof without reinforced concrete slab (a and b-totally destroyed).

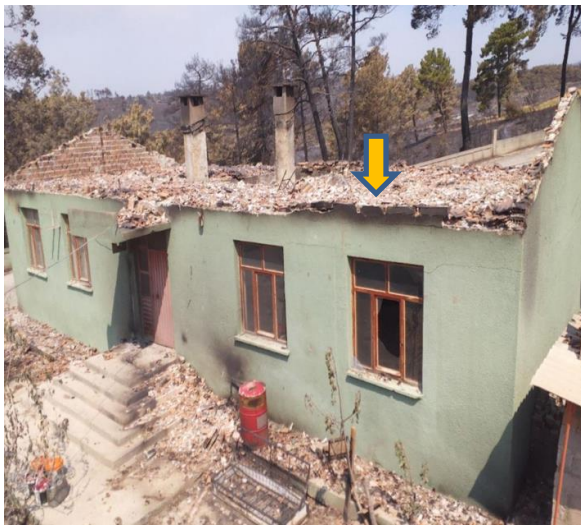
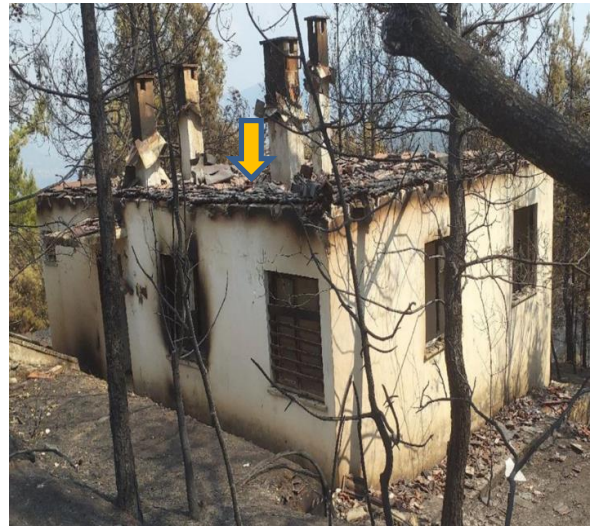
**Figure 12:** Timber roof with RC slab (a and b-less destruction)

2. In buildings with reinforced concrete slabs under the wooden roof, although the wooden roof was destroyed, less destruction occurred compared to the buildings that had no reinforced concrete slab under the wooden roof.

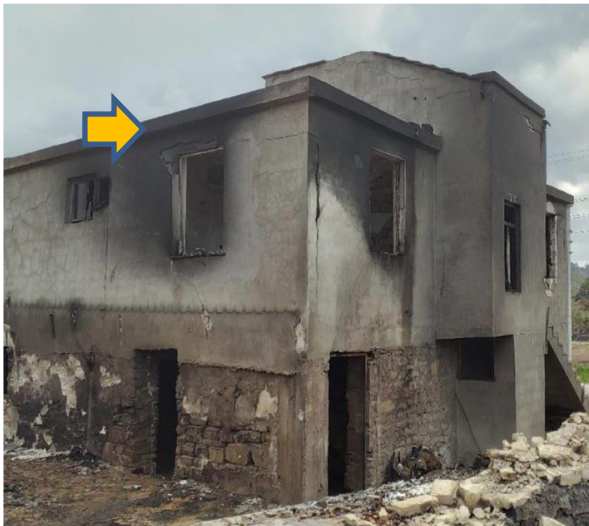
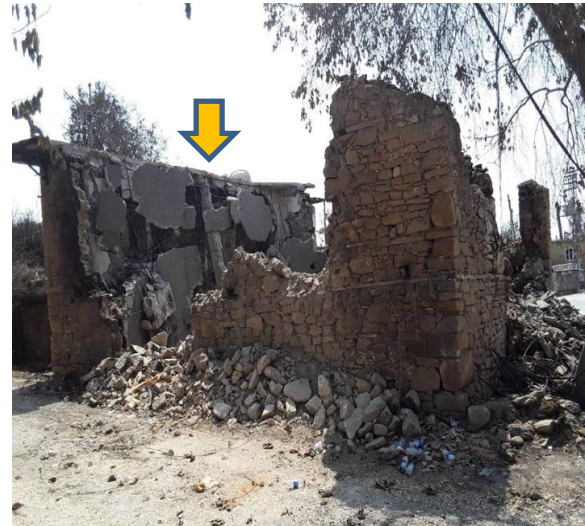
**Figure 13:** Reinforced concrete slab roofs (a and b)

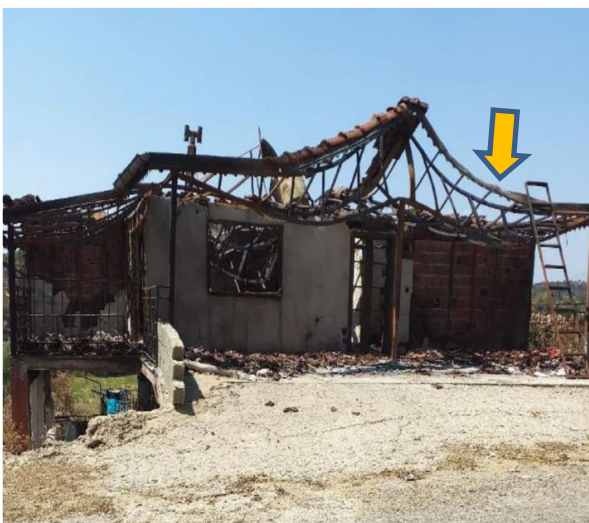
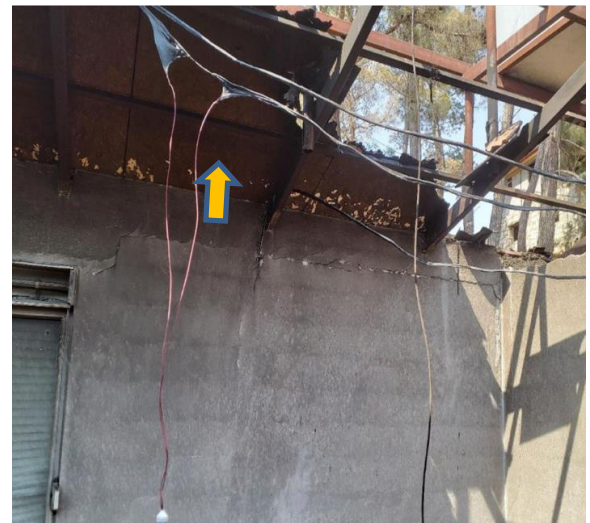
**Figure 14:** The timber on steel roofs- totally destroyed (a and b)

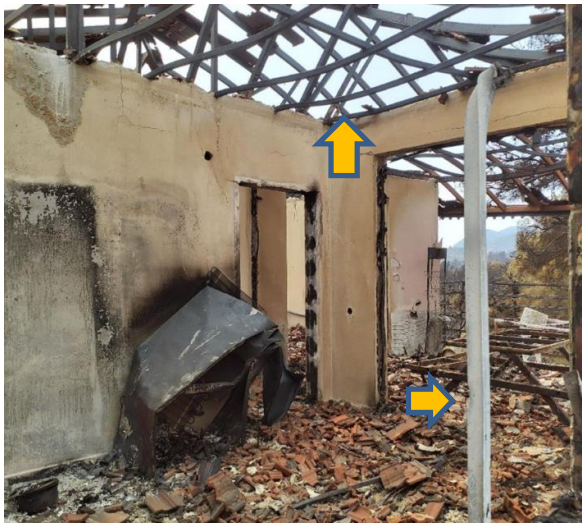
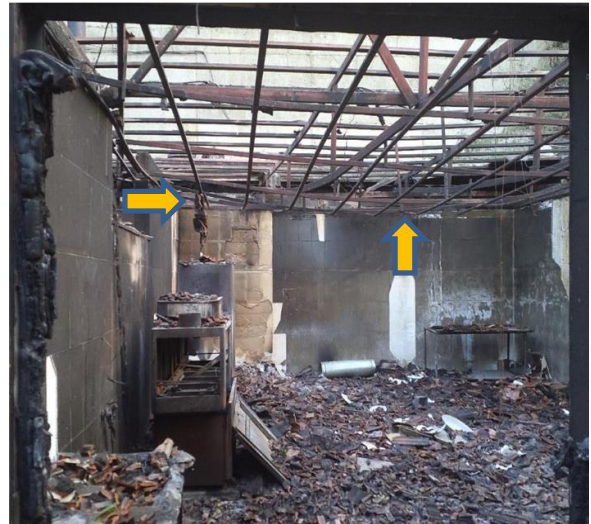
**Figure 15:** Light steel roofs-totally destroyed ( a and b)

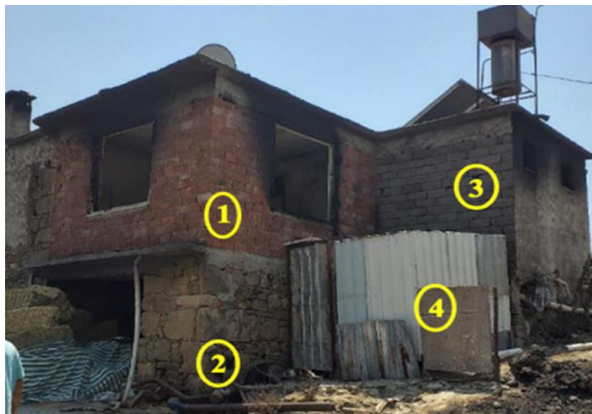
In the mixed system consisting of masonry walls and steel, the plasters on the walls were separated from the steel section and steel elements had big deformation when exposed to the fire. As seen in the photos (Figures 16 and 17), different types of structural materials presented different systems.

**Figure 16:** Damages in the mixed materials (four types of materials)

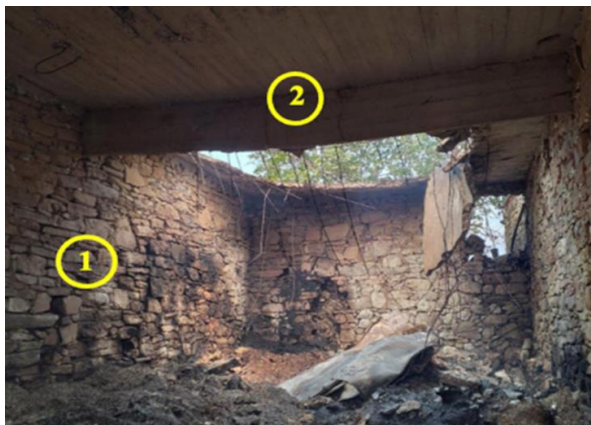
**Figure 17:** Damages in the mixed materials (two types of material)
